CLEAN AIR ACT SITE SURVEILLANCE REPORT **SUBJECT:**

General Iron Industries, Inc., Chicago, Illinois

Date of Site Surveillance: March 11, 2016

Purpose of Site Surveillance: The purpose of the site surveillance was to observe visible and

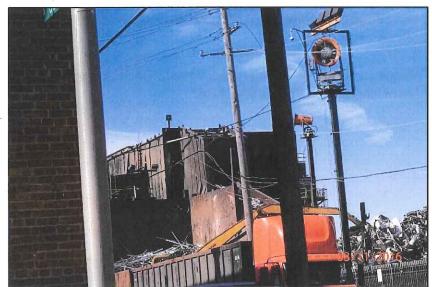
File Name	P3110001.JPG
Date Taken	03/11/16
Time Taken	9:41 AM
(approximate)	
Description	General Iron
•	shredder
54	
	9

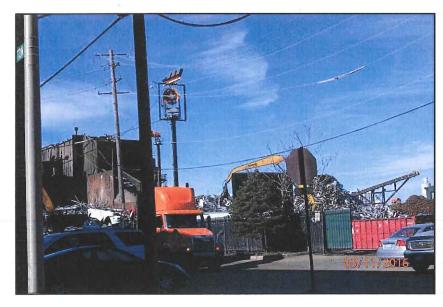
File Name	P3110002.JPG
Date Taken	03/11/16
Time Taken (approximate)	9:48 AM
Description	General Iron shredder and scrap piles
= 10	
	-

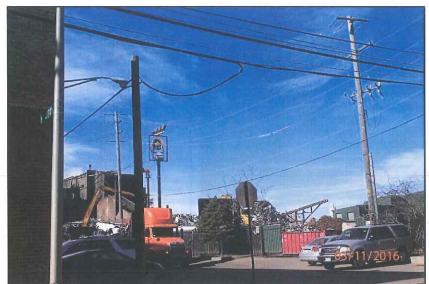
File Name	P3110003.JPG
Date Taken	03/11/16
Time Taken	9:54 AM
(approximate)	
Description	General Iron shredder and scrap piles

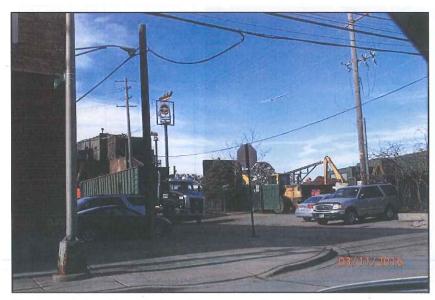
File Name	P3110004.JPG
Date Taken	03/11/16
Time Taken (approximate)	10:01 AM
Description	General Iron shredder and scrap piles

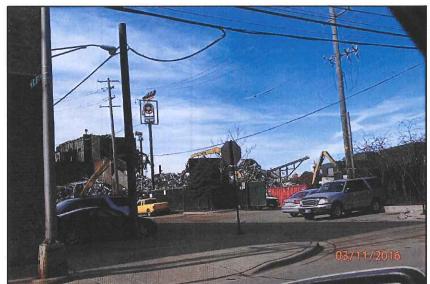
File Name	P3110005.JPG
Date Taken	03/11/16
Time Taken (approximate)	10:07 AM
Description	General Iron shredder and scrap piles
	=

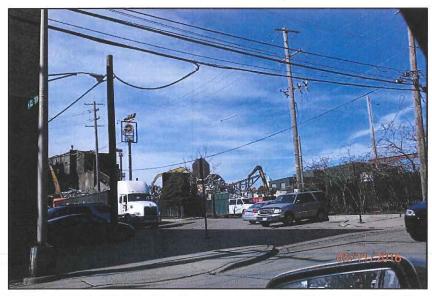
File Name	P3110006.JPG
Date Taken	03/11/16
Time Taken (approximate)	10:14 AM
Description	General Iron shredder and scrap piles
	=

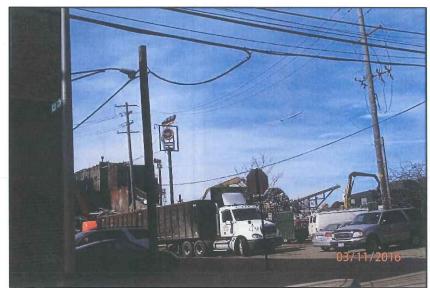
File Name	P3110007.JPG
Date Taken	03/11/16
Time Taken (approximate)	10:20 AM
Description	General Iron shredder and scrap piles
2

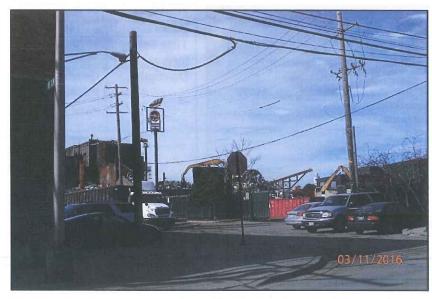
File Name	P3110008.JPG
Date Taken	03/11/16
Time Taken (approximate)	10:27 AM
Description	General Iron shredder and scrap piles

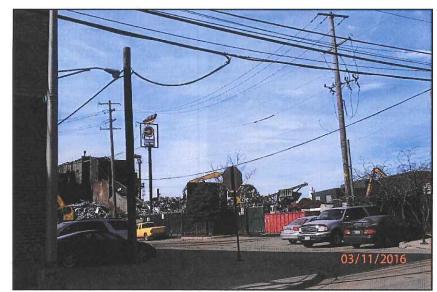
File Name	P3110009.JPG
Date Taken	03/11/16
Time Taken	10:32 AM
(approximate)	
Description	General Iron shredder and scrap piles
	4: n =
F as	e e
38 10	= 8

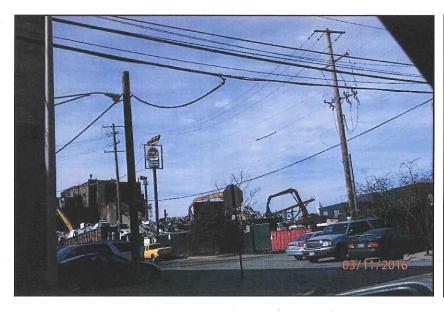
File Name	P3110010.JPG
Date Taken	03/11/16
Time Taken (approximate)	10:39 AM
Description	General Iron shredder and scrap piles
	8 _ =

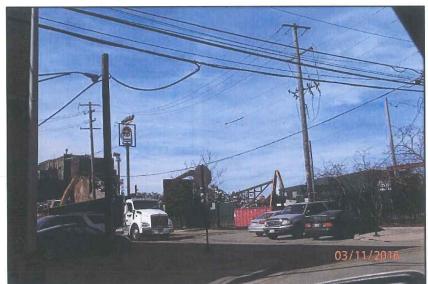
File Name	P3110011.JPG
Date Taken	03/11/16
Time Taken (approximate)	10:46 AM
Description	General Iron shredder and scrap piles

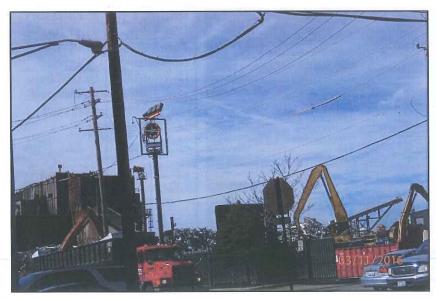
File Name	P3110012.JPG
Date Taken	03/11/16
Time Taken (approximate)	10:52 AM
Description	General Iron shredder and scrap piles
5

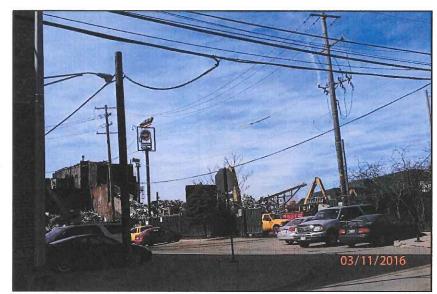
File Name	P3110013.JPG
Date Taken	03/11/16
Time Taken (approximate)	10:58 AM
Description	General Iron shredder and scrap piles
	, ,

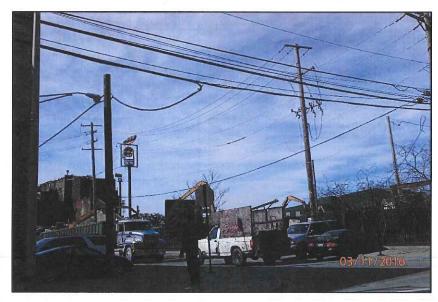
File Name	P3110014.JPG
Date Taken	03/11/16
Time Taken	11:04 AM
(approximate)	
Description	General Iron shredder and scrap piles
_

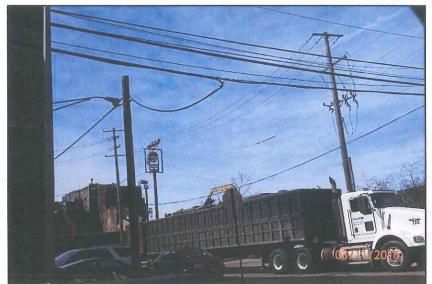
File Name	P3110015.JPG
Date Taken	03/11/16
Time Taken	11:10 AM
(approximate)	2
Description	General Iron shredder and scrap piles
,
